Emergency Response (D0)

RDA# WW3065621

Subject: Potential Unit shifting during board mount process for 5x6 PQFN assembled from ASEWH

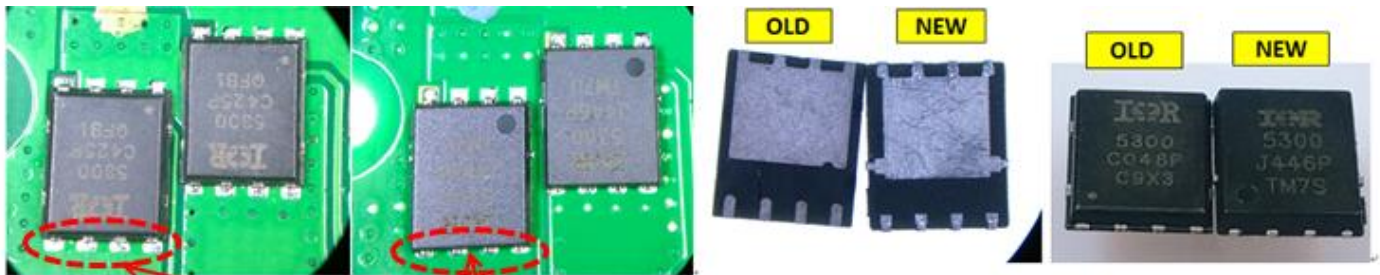
Actual verification of shipped lots showed that unit slightly moved downward compared to units assembled from IR's pilot site.

■ Unit moved but still with solder connection on both ends

Technical Root Cause: POD difference from ASEWH site specifically the E-2 and L dimension had potentially contributed to the unit shift during reflow process. However, take note that based on previous POD analysis/ simulation, the difference was not expected to create any solder ability issue except that there is some visible shifting.

1. Re-issue PCN with detailed POD changes, see attached
2. Address Process Change Review procedure to prevent re-occurrence by ensuring all changes are disclosed to Operations review team to verify what change notification details are required for future PCN's.
