# PowerSpan II™ Device Errata and Design Notes

80A1010\_ER001\_13

November 4, 2009

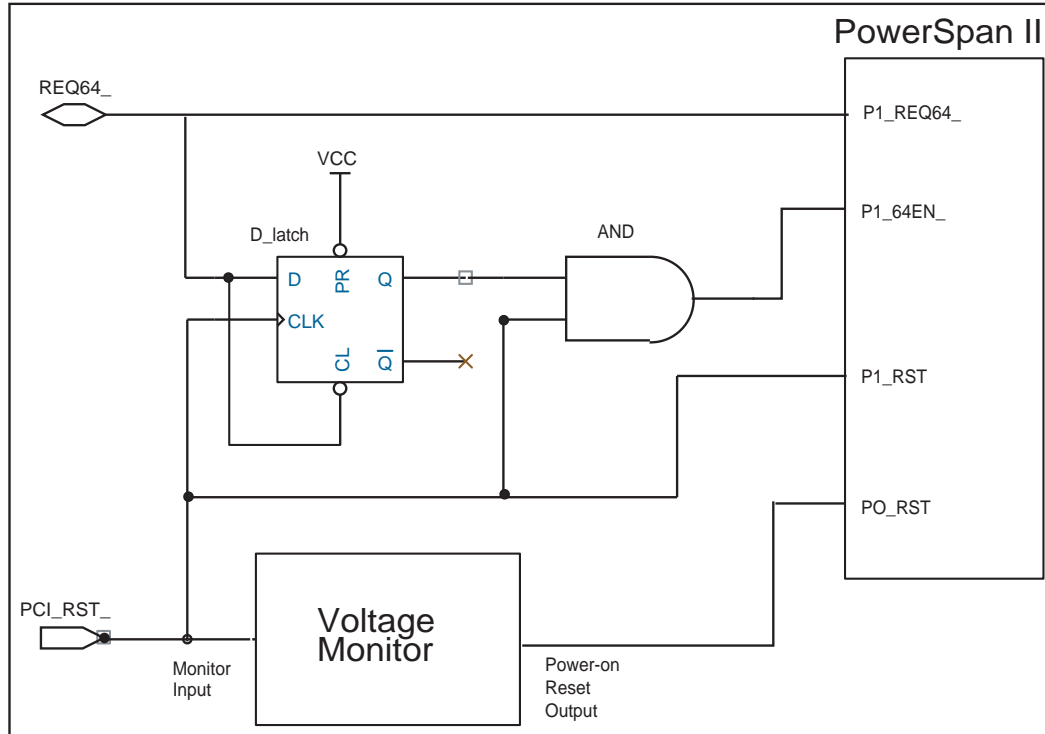
Figure 1: Logic Required to Delay Deasserting PO\_RST\_ to PowerSpan II

A customer used PowerSpan II in a PCI adapter card application. In this particular application, PO\_RST\_ was generated by a local voltage monitor device, while P1\_CLK was provided by the system controller board through the backplane. Under certain power-up events, P1\_CLK only became stable after the local PO\_RST\_ was deasserted because of different power ramping between the adapter card (containing PowerSpan II) and the system controller card. As a result of the application violating the clock and reset timing restrictions, the PowerSpan II PCI interface does not claim any transactions after reset.

By generating PO\_RST\_ off of PCI\_RST\_, there is a chance that the PowerSpan II will be unable to latch the state of the REQ64\_ signal on deassertion of PCI\_RST\_. Therefore, an external D-Latch is used to capture the state of REQ64\_ to determine the width of the bus (see [Figure 1](#)). The purpose of the asynchronous clear on D-latch is to prevent potential bus contention on the REQ64\_ signal which is driven by PowerSpan II on the deassertion of P1\_RST\_ in a 32-bit system. The P1\_64EN\_ signal, which is originally used for CompactPCI Hot Swap applications, is used here to tell the PowerSpan II if this is a 32 or 64-bit application. The AND gate is AND-ing the output of D-latch with PCI\_RST\_ to ensure the P1\_64EN\_ is low when the D-latch power-up with uncertain output.

Each PCI\_RST\_ assertion leads to a corresponding assertion on PO\_RST\_. Therefore, the PowerSpan II Multiplex System Pin Mode Power-up option’s timing must be met with each toggle of the PCI\_RST\_ signal.

The proposed work-around to this situation is to delay deasserting PO\_RST\_ to PowerSpan II until the host deasserts the PCI\_RST\_ signal. Since the PCI\_CLK is an output from the system controller along with PCI\_RST\_, the negation of PCI\_RST\_ implies the PCI\_CLK is stable. The local voltage monitor uses PCI\_RST\_ to make sure that the PCI\_CLK is stable before the deassertion of PO\_RST\_. A possible implementation of this circuit is shown in [Figure 1](#).

Figure 1 shows the logic required to delay deasserting PO\_RST\_ to PowerSpan II until the host deasserts the PCI\_RST\_ signal.

If the external glue logic shown in Figure 1 is implemented by a CPLD, make sure the CPLD output and Flip-flop state are not affected by any reset.

This work-around only applies to designs where PowerSpan II is in a PCI adapter card and is configured for a non-Hot Swap environment. Normally in this scenario, the PCI bus width is indicated by P1\_REQ64\_ signal (P1\_64EN\_ is pulled high). For designs where PowerSpan II is in a PCI host card or it is configured for a Hot Swap environment, the circuit shown in Figure 1 must not be used.
