This errata sheet provides updated information about known device issues affecting Arria® II GX devices.

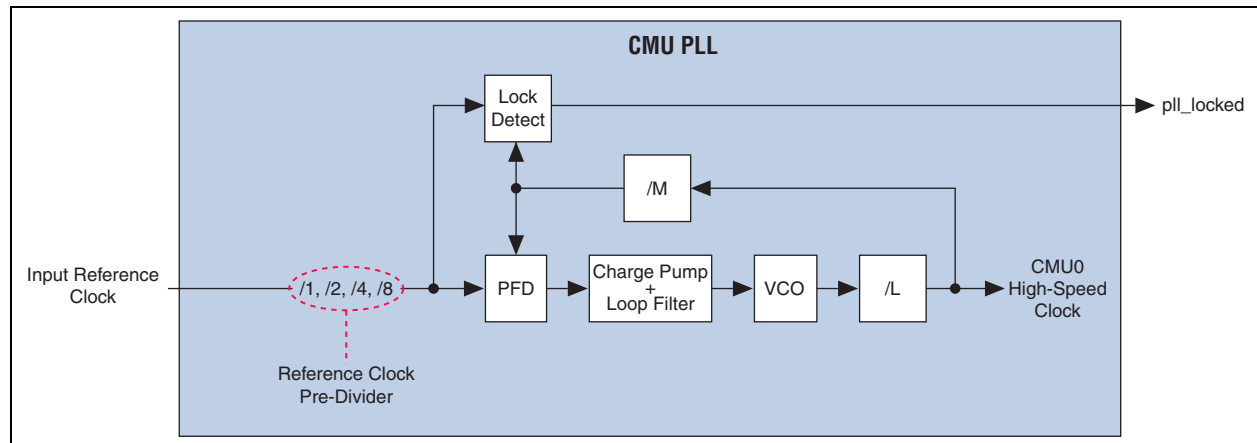
Figure 1. Reference Clock Pre-Dividers in Transmitter PLLs

The transmitter phase-locked loop (PLL) lock status signal (pll_locked) does not de-assert when the pll_powerdown signal is asserted in configurations that use the reference clock pre-divider of 2, 4, or 8. [Figure 1](#) shows the reference clock pre-divider inside transmitter PLLs. This issue impacts the pll_locked status signal in the clock multiplier unit (CMU) PLL.

If the pll_locked issue impacts your design, instantiate and connect the pll_locked_soft_logic module, as shown in **Figure 3**. You must use the pll_locked_to_corelogic output from this module in the transceiver reset logic and any user logic that relies on the transmitter PLL lock status signal.
